## Why Deflection Matters For Plastic Pipe

## Paul Imm, P.Eng.

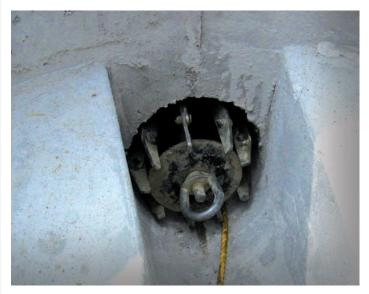
Mandrel test starting at a Maintenance Hole

For the ring deflection test, OPSS 410 requires a suitably designed mandrel, cylindrical in shape, and constructed with an odd number (minimum of 9) of evenly spaced arms or prongs. The minimum diameter of the circle scribed around the outside of the mandrel arms is equal to the allowable deflected pipe diameter ± 1 mm. As the mandrel is pulled through a pipeline, any section that does not allow the mandrel to pass

is considered to have failed the deflection test. The mandrel pull is the most common field test for checking ring deflection, however because it is only a go/ no-go test new technology like laser profiling is gaining popularity as an accurate method of measuring deflection which is also becoming less cost-prohibitive.

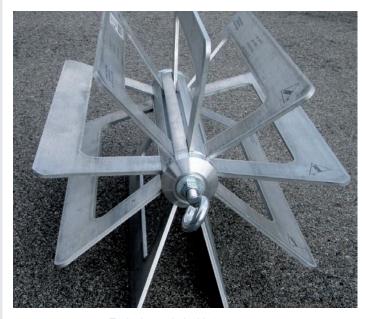
Typical mandrel with 9 arms

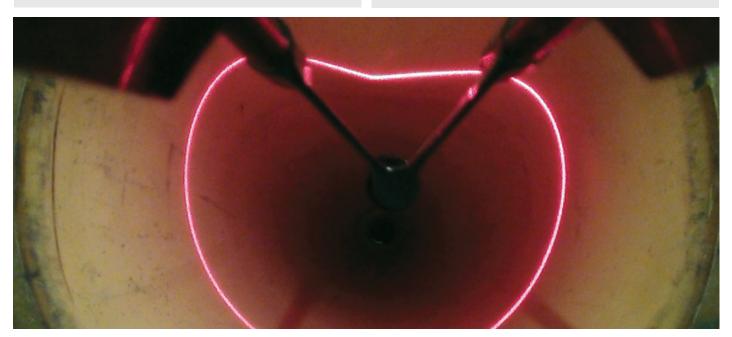
Inverse curvature outlined by laser profiler (Image: Courtesy of Maverick Inspection Ltd.)

A laser profiler is a tool that can be mounted to a CCTV camera, a laser ring is projected onto the internal surface of the pipe and the recorded video image is then processed by computer software to produce a continuous, 3D model of the pipeline. This information can be easily analyzed for deflection issues and becomes an invaluable tool for asset management departments to determine if a pipe is changing by comparing laser profile reports over time.
